**Flood Control Project Maintenance
Levee Inspections**
LMA District Cover Sheet
Spring 2018 Levee Inspection Results

Reclamation District No. 0765 Glide

Spring 2018 Levee Inspection Results

Waterway			Bank	Unit Miles
Unit No. 01 Sacramento River			Right	1.72
	Spring (March - May)	Summer (June - August)	(September - November) Fall	Winter (December - February)
Unit Maintenance Rating (Fall Only)				
Date of Inspection	3/7/2018 - 3/7/2018			
DWR Inspector	Dave Torres			
Accompanied By	David Dickson RD765

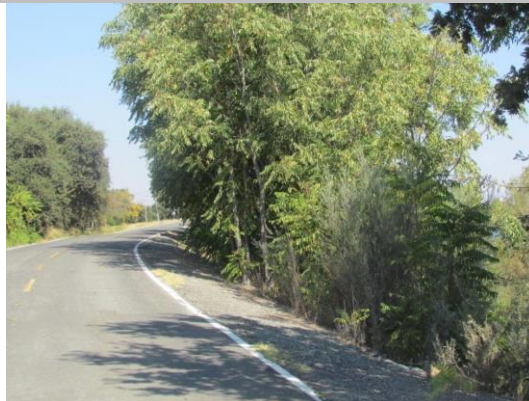
Photo 3 of 4 : SP_2018_RD0765_211_24_20180301_00027.jpg

LM Start	0.45	Rating **	U	Issue No.	24 (cont)	
LM End	0.47	Issue Type +	Ma	Location *	WS	
Category	Earthen Levee			GPS Latitude/Longitude		
				Start		End
Item	Trim / Thin Trees			38.496534 °		38.496249 °
				-121.559880 °		-121.559760 °
DWR ID	DWR_RD0765_01_s_2012_24					
Comment Code						
T2 : Thin trees to allow visibility of the ground and room to flood fight.						
Inspector Comment						
Dense willows and untrimmed trees on waterside slope has been untrimmed for multiple inspection cycles.

Looking northeast at large cluster of trees on waterward slope. (Fall 2016)

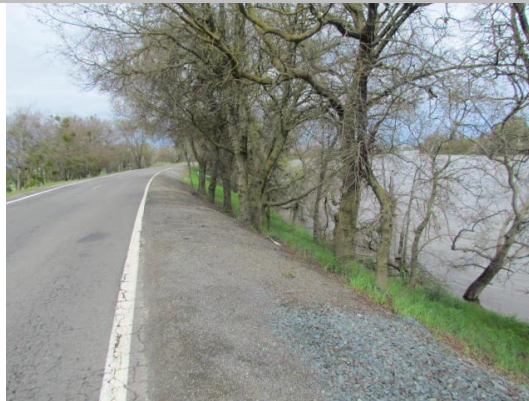
Photo 1 of 1 : SP_2018_RD0765_211_10_20180301_00014.jpg

LM Start	0.56	Rating **	M	Issue No.	10
LM End	0.59	Issue Type +	Ma	Location *	WS
Category	Earthen Levee			GPS Latitude/Longitude	
				Start	End
Item	Trim / Thin Trees			38.495035 °	38.494642 °
				-121.559027 °	-121.558697 °
DWR ID	DWR_RD0765_01_s_2016_10				
Comment Code					
T2 : Thin trees to allow visibility of the ground and room to flood fight.					
Inspector Comment

Looking northeast at trees on waterward slope.

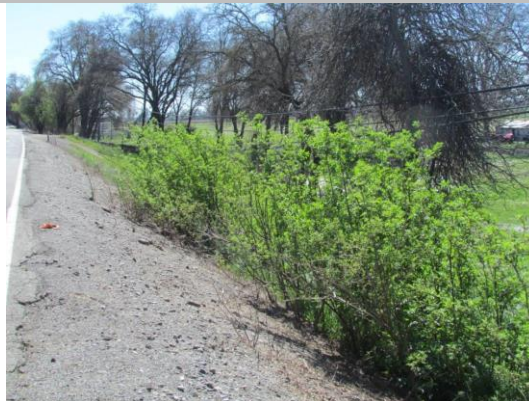
Photo 1 of 2 : SP_2018_RD0765_211_40_20180301_00047.jpg

LM Start	0.92	Rating **	U	Issue No.	40 (cont)
LM End	0.97	Issue Type +	Ma	Location *	LS

Looking south at new growth on landward slope. (Spring 2017)

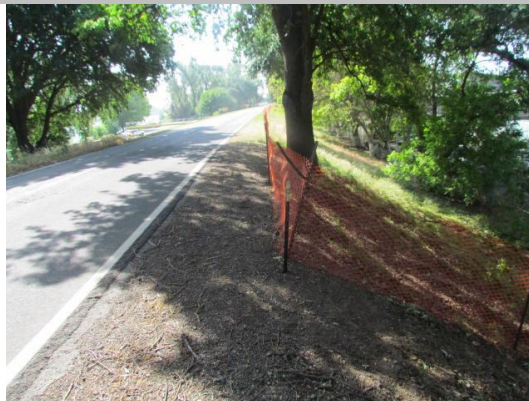
Photo 3 of 3 : SP_2018_RD0765_211_54_20180301_00065.jpg

Looking south at temporary fence on landward slope. (Spring 2016)

LM Start	1.16	Rating **	M	Issue No.	54 (cont)
LM End	1.26	Issue Type +	En	Location *	LS

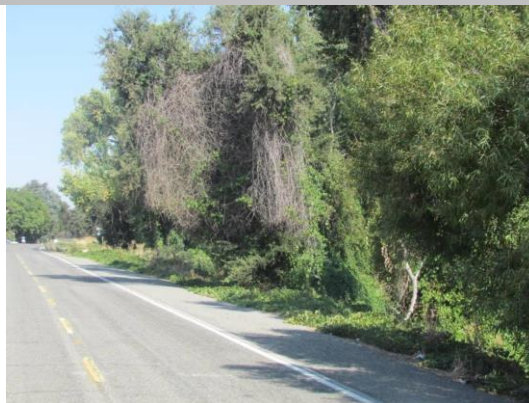
Photo 1 of 3 : SP_2018_RD0765_211_4_20180301_00006.jpg

LM Start	1.37	Rating **	M	Issue No.	4
LM End	1.37	Issue Type +	Ma	Location *	WS
Category	Earthen Levee			GPS Latitude/Longitude	
				Start	End
Item	Trim / Thin Trees			38.484563 °	38.484563 °
				-121.552289 °	-121.552289 °
DWR ID	DWR_RD0765_01_s_2012_4				
Comment Code					
T1 : Trim trees to at least five feet above ground level.					
Inspector Comment

Looking northeast at untrimmed trees and other vegetation on waterward slope. (Fall 2016)

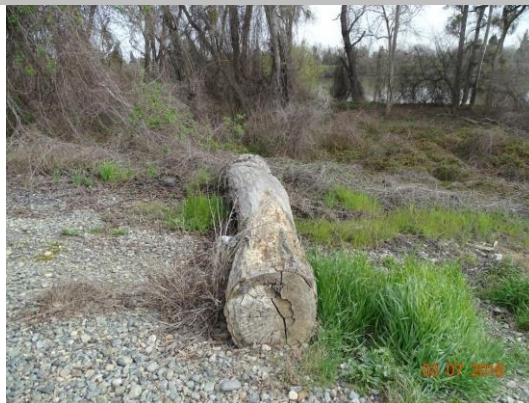
Photo 1 of 1 : SP_2018_RD0765_211_45_20180308_00093.jpg

LM Start	1.51	Rating **	A/W	Issue No.	45
LM End	1.51	Issue Type +	Ma	Location *	WS
Category	Earthen Levee			GPS Latitude/Longitude	
				Start	End
Item	Encroachments			38.482835 °	38.482835 °
				-121.551083 °	-121.551083 °
DWR ID	DWR_RD0765_01_s_2018_45				
Comment Code					
TR : Tree or limb					
Inspector Comment					
Used to control vehicle traffic access to levee.

Encroachment downed tree waterside used to control vehicle access looking northeast.

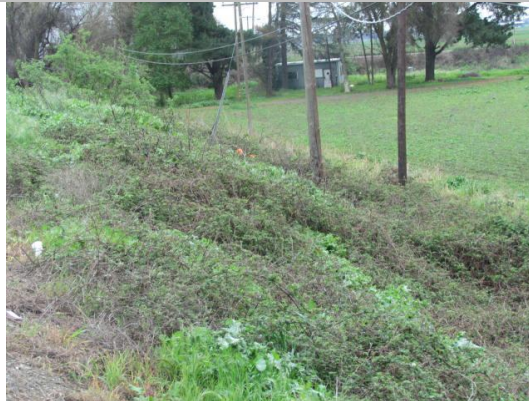
Photo 5 of 5 : SP_2018_RD0765_211_29_20180301_00037.jpg

LM Start	1.52	Rating **	U	Issue No.	29 (cont)
LM End	1.62	Issue Type +	Ma	Location *	LS

Looking southwest at ground cover on landward slope. (Spring 2016)

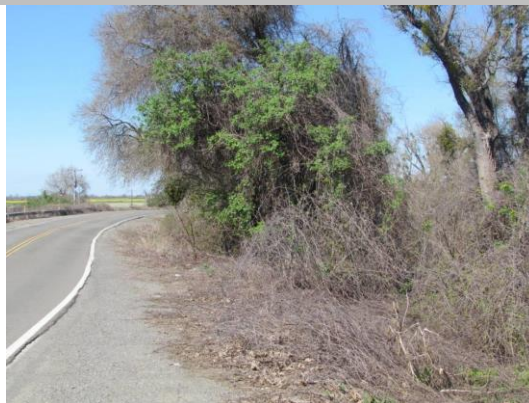
Photo 1 of 2 : SP_2018_RD0765_211_53_20180301_00061.jpg

LM Start	1.66	Rating **	U	Issue No.	53
LM End	1.67	Issue Type +	Ma	Location *	WS
Category	Earthen Levee			GPS Latitude/Longitude	
				Start	End
Item	Trim / Thin Trees			38.480892 °	38.480800 °
				-121.549654 °	-121.549583 °
DWR ID	DWR_RD0765_01_s_2013_53				
Comment Code					
T1 : Trim trees to at least five feet above ground level.					
Inspector Comment					
Untrimmed trees on waterside slope.

Looking north at dense untrimmed trees on waterward slope. (Spring 2017)

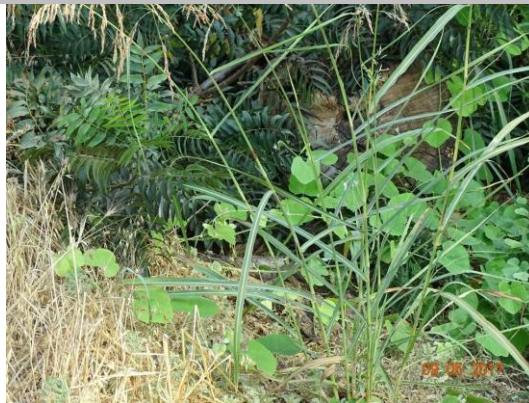
Photo 1 of 2 : SP_2018_RD0765_211_13_20180301_00017.jpg

LM Start	1.67	Rating **	M	Issue No.	13
LM End	1.68	Issue Type +	Ma	Location *	WS
Category	Earthen Levee			GPS Latitude/Longitude	
				Start	End
Item	Encroachments			38.480763 °	38.480632 °
				-121.549581 °	-121.549543 °
DWR ID	DWR_RD0765_01_s_2012_13				
Comment Code					
PR : Prunings					
Inspector Comment					
Large tree branch on waterside slope.

Looking northwest at tree limb in vegetation on waterside slope.
